FATIGUE ASSESMENT OF TURBINE BLADE BASED ON SURFACE COATING DEGRADATION AFTER EXTREME LOADING

Pavlas J. ¹, Slavík S. ², Růžička M. ³, Mára V. ⁴, Krčil J. ⁵

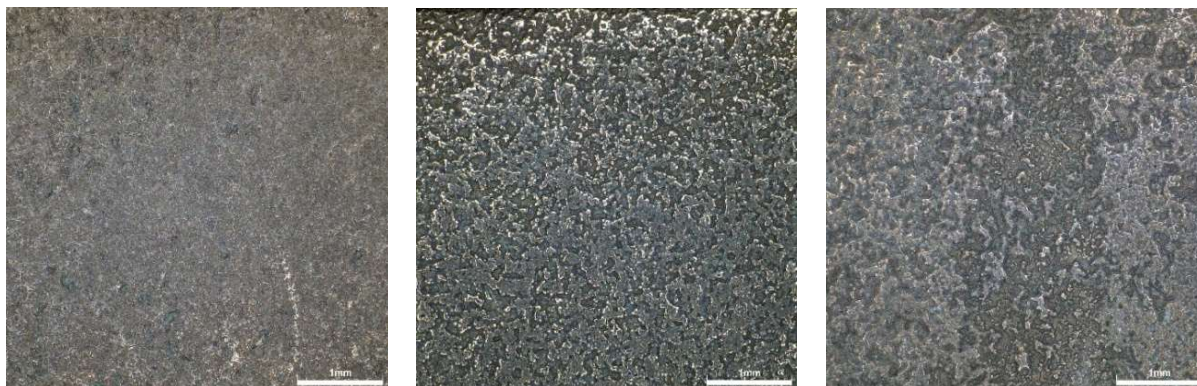
Protective coating damage is classified into three basic categories. After GO, the blade surface is smooth and free of damage. During service, the first visually detectable material loss may occur. Major damage, characterized by large areas of missing protective coating, can rapidly lead to burn-out of the substrate material (Fig. 3).

Fig. 3: The turbine blade coating damage during the service life: initial (after GO procedure including ground test: less than 1% coating damage - left), first visual detectable damage (after 520 Flight hours: 13% coating damage - middle), major damage (after 819 Flight hours: 32% coating damage - right)

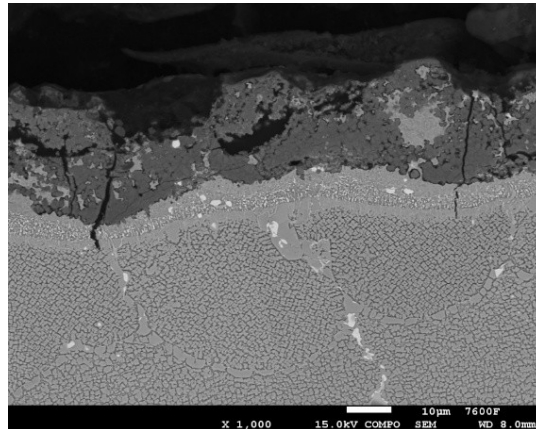
The fatigue cracks initiated from protective coating damage are shown in Fig. 4. Several fatigue cracks are across the protective coating. In some areas the protective coating is damaged. Initial fatigue microcracks are also present in the substrate material.

Fig. 4: The cross section of the turbine blade with first microcracks in the coating layer and substrate material (after 1132 Flight hours)
