NEW RECOGNITION TECHNOLOGY FOR FLUID SYSTEMS CONTAMINATION

Jiří Stodola^{*)}

Summary: *Monitoring of technical condition of machines (e.g. engines) based on used oil analysis is an urgent practice to optimize control and maintenance. Both perfect wear products knowledge and used oil contamination is of crucial importance in order to make inspection, corrections or maintenance. The LaserNet Fines (LNF) technology [1] combines the technique of standard oil analysis, i.e., identification of number of wear and debris particles, automatic wear particle shape classification and trending tool to assist users in the field of ferrography. The LNF unit is a bench-top automated oil debris analysis unit which is a particle counter and shape classifier identifying sizes and trends wear particles and debris in all types of lubricants and hydraulic fluids.*

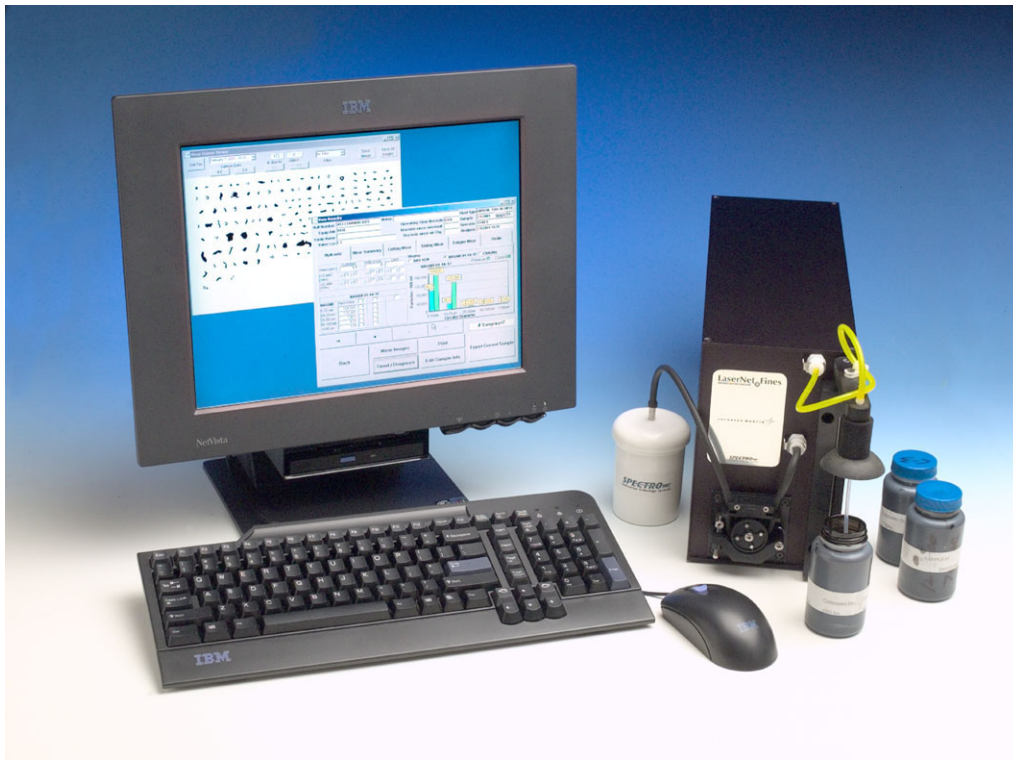
Figure 1: LaserNet Fines Particle counter and Shape Classifier

require any special type of gases or fluids. Its main components are: Collimated Laser Diode, Progressive Scan Camera, Flow Cell, Computer with Frame Grabber, Imaging Optics and Operating and Data Analysis Software [1].

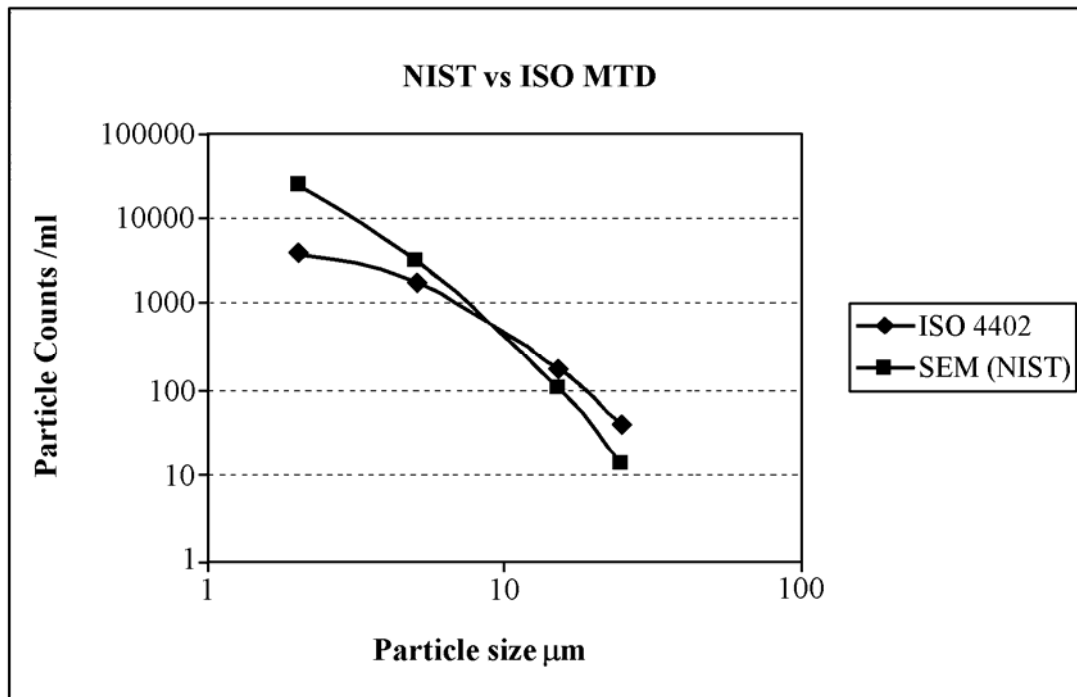
Figure 4: Significant difference between the two distributions when an automatic particle counter is calibrated with two measures

The test dust size distribution was measured using a sieve and optical microscope resulting in a size distribution based on maximum diameter. There is a significant difference between the two distributions and this can be shown; an automatic counter calibrates with Fine Test Dust (FTD) measures an ISO [11] as measured with a scanning electron microscope, see Figure 4. The equivalent circular diameter used by NIST regulation [11] for the same particle distribution is smaller than the maximum diameter used in the FTD, see Figure 5. A particle counter is calibrated using the new ISO regulation; the size of any solid particulate sensed will be over estimated because it will be blocking more light than a particle of the same diameter with transparent areas which it was calibrated with, see Figure 6.

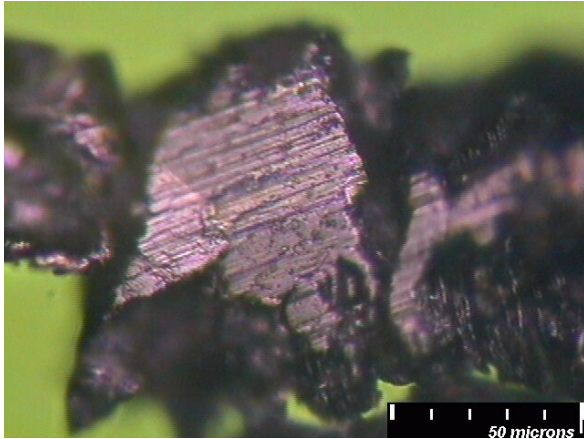
Figure 7: Severe sliding wear particle, approximately 75 μm

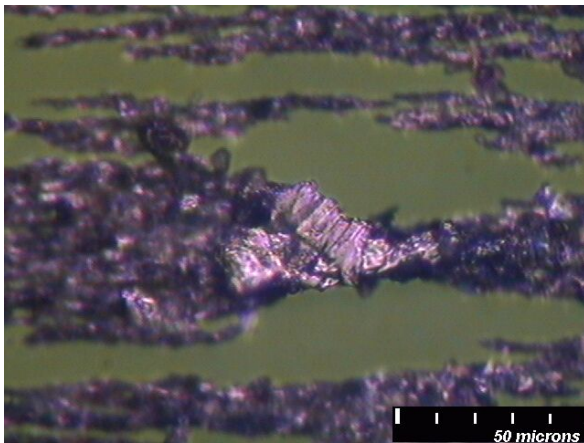
Figure 8: Two large particle 30 μm , generated during break-in

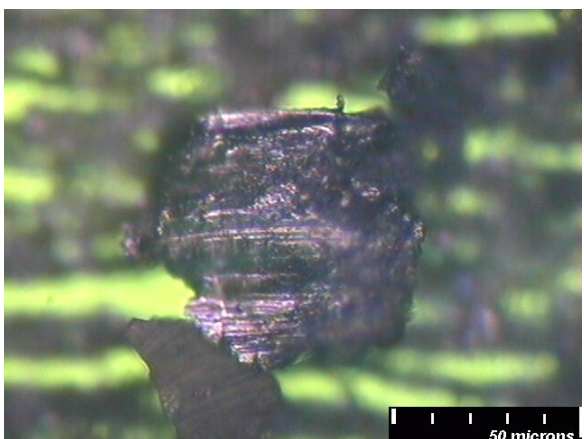
Figure 9: Chunky, 70 μm , during break-in wear
