## **REPAIRING AND REINFORCING LOAD BEARING ELEMENTS OF TIMBER STRUCTURES, DAMAGED BY BIO-DEGRADATION**

**Abstract:** *Many historical timber constructions are damaged by biodegradation especially by ligniperdous insect. Sometimes the degradation is so high, that some construction members need to be replaced or reinforced. In common buildings we can use many known methods to repair damage. But in historical buildings we must mind visual aspect and Bureau of care of historical monuments. According to their demands we are not able to replace whole members also repaired timber element must look like original members. This article describes the method which can be used in such cases.*

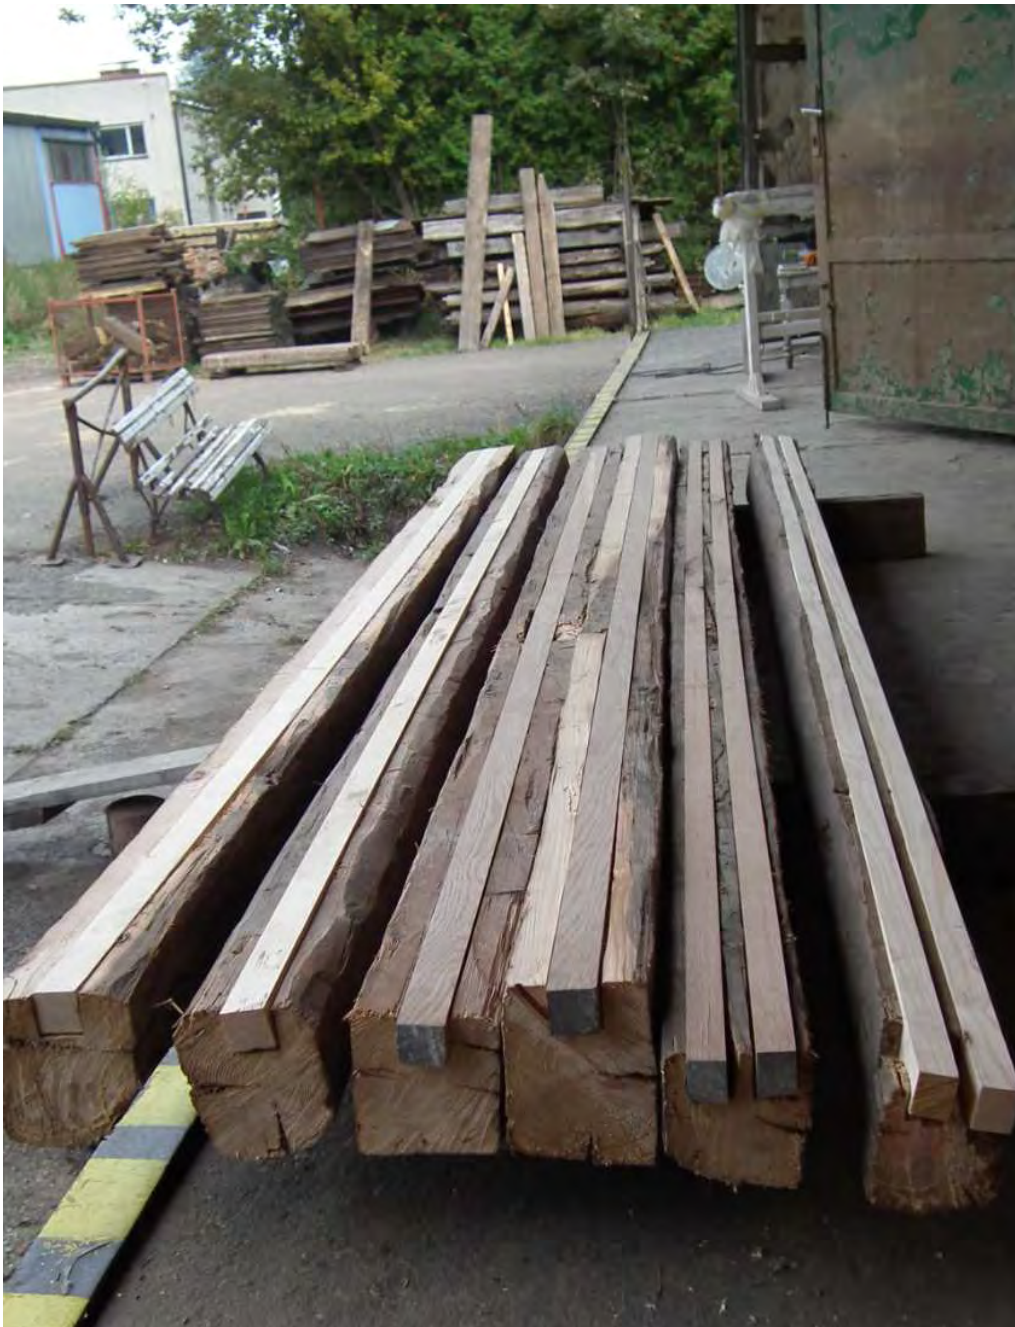
*Fig. 1: Timber members damaged by ligniperdous insect with embed reinforcing core*

Method of reinforcing timber members using wooden core with higher strength can be used only for timber damaged by ligniperdous insect. Ligniperdous bugs do not cause change of wood structure as do wood-decaying funguses. Insects cause decrease of wood mass based on classical foundations (Reinprecht, 2008). If the stage of decay is not high it is possible to use reinforcing method.

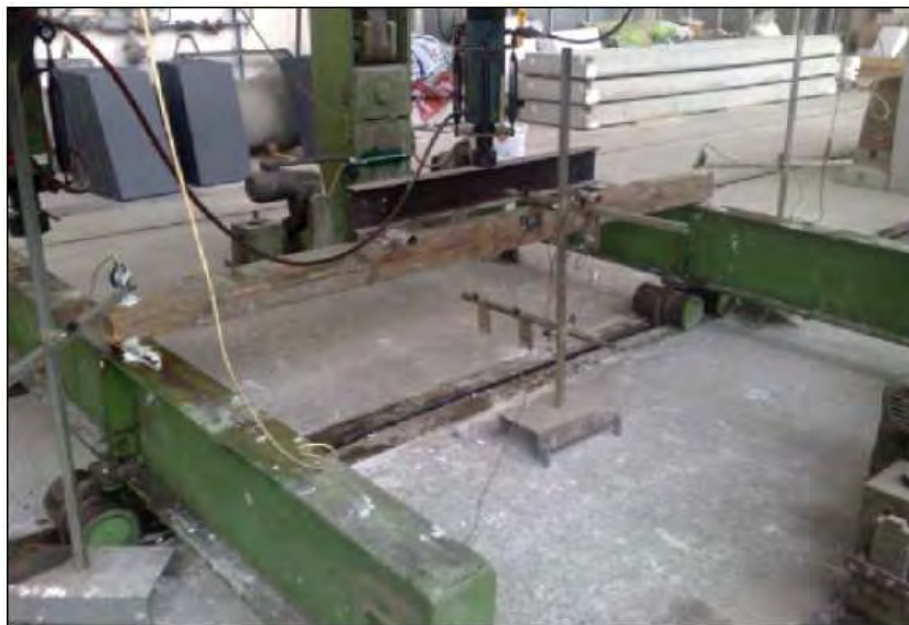
*Fig. 3: Test of load bearing capacity in TZÚS Ostrava*

Laboratory tests were performed on presser line 600 kN (Fig.3). Samples were set on hinge supports and loaded in thirds of span with point force (Fig.5) using similar work progress as described in paper (Lokaj et al., 2011) published in Transactions of VŠB-Technical University of Ostrava . For comparison with analytic and numerical model (FEM) there was chosen sample nr. 8 the member with one inserted oak core (40x40 mm) at the bottom of the cross section.

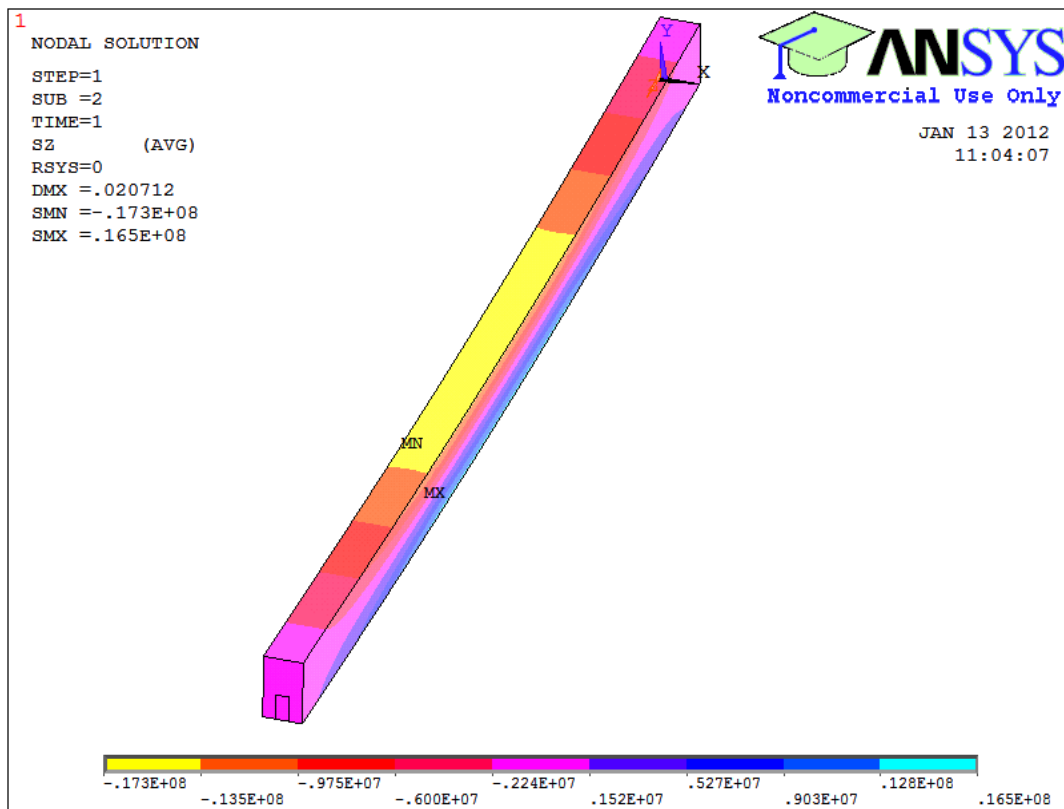
Fig. 9: Normal stress on the beam

Difference between results (tension at the bottom of the cross section) from the analytic calculation and numerical model is around 10 %. These results can be compared to result of the test on the Fig.10.
