BEARING FAULT DETECTION OF AUTOMOTIVE GEARBOX USING ORDER ANALYSIS

Sann S.[1], Tomeh E.[2]

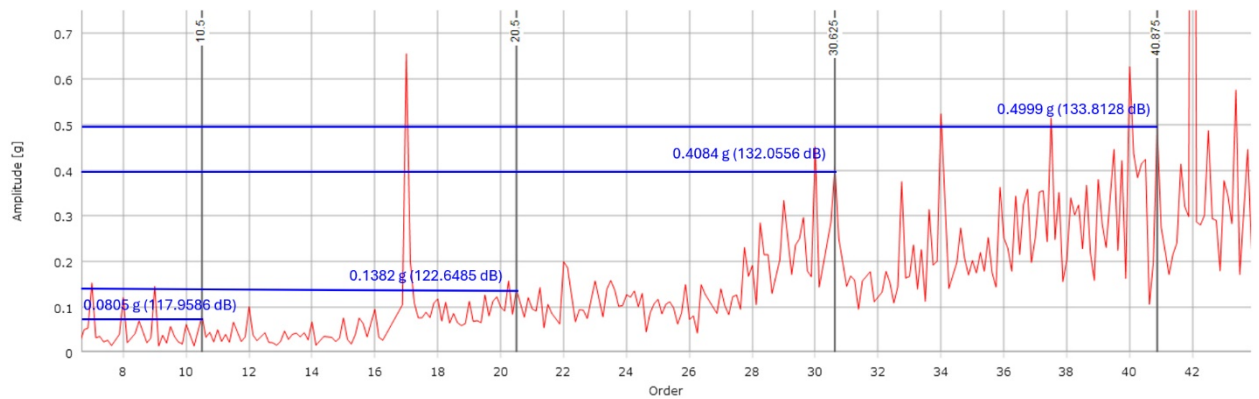
Fig. 4: Load step 201: crankshaft speed (3100-3399 RPM), gear (3.50-4.50), torque (50-100 Nm), oil temperature (79.50-103°C), Bearing 3: inner ring

In Fig. 4, load step 201 of inner ring of bearing 3 was chosen to analyse where crankshaft speed ranged from 3100 RPM to 3399 RPM, gear between 3.50 and 4.50, torque from 50 Nm to 100 Nm, and oil temperature ranged from 79.50°C to 103°C. The 1^{st}, 2^{nd}, 3^{rd}, and 4^{th} harmonic components of 0.0805g, 0.1382g, 0.4084g, and 0.4999g gradually increased. This indicates the effect of clearance of inner ring of bearing 3 at the 4^{th}-speed degree.

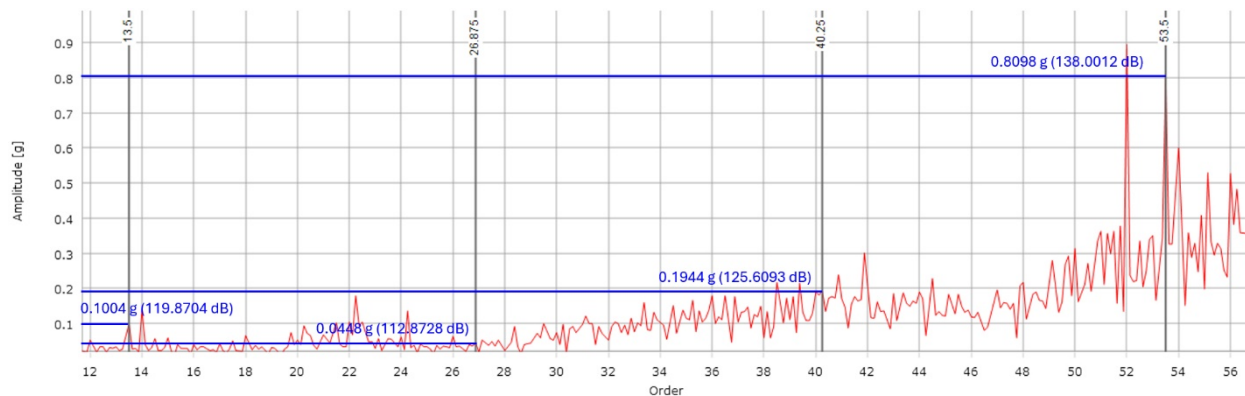
In Fig. 5, load step 293 of inner ring of bearing 3 was selected to analyze where crankshaft speed ranged from 1600 RPM to 1899 RPM, gear between 4.50 and 5.50, torque from 100 Nm to 150 Nm, and oil temperature ranged from 79.50 to 103°C. The 1^{st}, 2^{nd}, 3^{rd}, and 4^{th} harmonic components of 0.1004g, 0.0448g, 0.1944g, and 0.8098g gradually increased. This indicates the effect of clearance of inner ring of bearing 3 at the 5^{th}-speed degree.

Fig. 5: Load step 293: crankshaft speed (1600-1899RPM), gear (4.50-5.50), torque (100-150 Nm), oil temperature (79.50-103°C), Bearing 3: inner ring
