THREE-POINT BENDING FATIGUE DAMAGE MECHANISMS ASSOCIATED WITH THE DIFFERENT STRUCTURE OF AL-MG CAST ALLOYS

M. Uhříčik*, M. Oravcová*, P. Palček*, M. Chalupová*, L. Kuchariková*

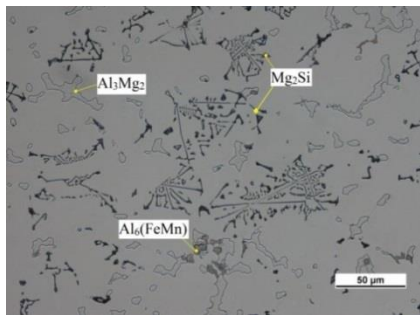
Fig. 1: Microstructures of alloys EN AC 51200.

Considering that alloys were casted under the same technological conditions, it can be said that the structure affects only the chemical composition of alloys. Microstructure of materials is expressively dendritic (Fig. 1 and Fig. 2). The highest percentage representation of dendrites has α -phase (matrix) that is a solid solution of aluminium together with other additive elements. In the structure, there is also an

intermetallic phase Mg_2Si . This phase has a different morphology in alloys. In the case of EN AC 51200 alloy, it has a shape of skeleton formation and is distributed in interdendritic areas. There is also β -phase, which is formed in interdendritic areas and has a stoichiometric basis Al_3Mg_2 . In alloy EN AC 51500, intermetallic phase Mg_2Si has a finer morphology and does not have a typical shape of skeleton formation. Because elements such as iron and manganese are also in alloys, can be observed a small amount of Fe-rich phase in structure of both materials, probably $Al_6(FeMn)$. β -phase is not present in this alloy, because of the smaller content of magnesium.

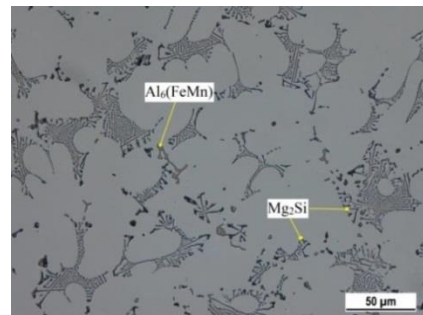
Fig. 2: Microstructures of alloy EN AC 51500.

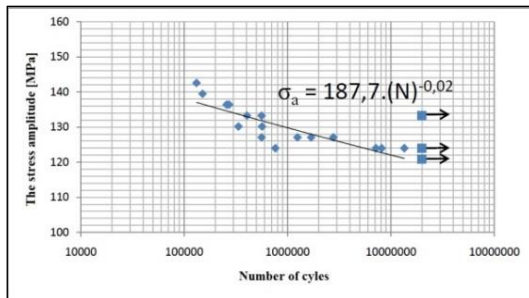
Fig. 3: Results of fatigue tests for alloy EN

AC 51200.

Fatigue tests were carried out on the test equipment ZWICK/ROELL AMSLER 150 HFP 5100 according to norm STN 42 0363. This equipment is using the resonance principle with constant or variable amplitude and mean load. Smooth rectangular specimens without notches (10 x 18 x 40 mm) were loaded by cyclic three-point bending loading with mean stress $\sigma_m = -144$ MPa and frequency 120 Hz, only stress amplitude was changing. From results of fatigue tests were constructed graphs $\sigma_a - N$ in semi-logarithmic coordinates, for every alloy (Fig. 3 and Fig. 4). By comparing of graphs can be stated that alloy EN AC 51500 has better fatigue properties than alloy EN AC 51200 in analyzed area of the number of cycles.

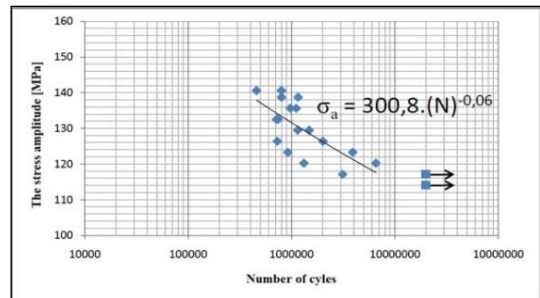
Fig. 4 Results of fatigue tests for alloy EN AC 51500.

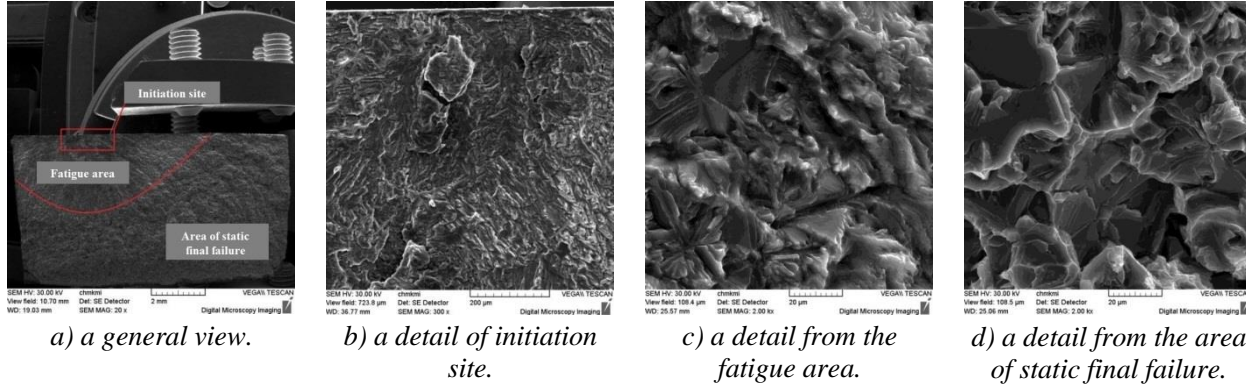
Fig. 5: Fracture surface of aluminium alloy 51500, $\sigma_a = 120$ MPa, $N_f = 1314148$ cycles.

A general view of the fracture area for the alloy EN AC 51500 after 1314148 cycles at a stress of 120 MPa is documented in Fig. 5a, where can be seen various stages of fatigue process. Detail of initiation site is shown in Fig. 5b. Transgranular fatigue failure of α -phase (matrix) and there were observed typical signs of fatigue – striations and also an interfacial and a fission failure of Mg_2Si phase, this all is shown in Fig. 5c. Fig. 5d displays the area of static final failure, where can be seen plastic's transformed ridges of α -phase, together with a transgranular ductile fracture of α -phase with dimple morphology and also is visible an interfacial failure of Mg_2Si phase.

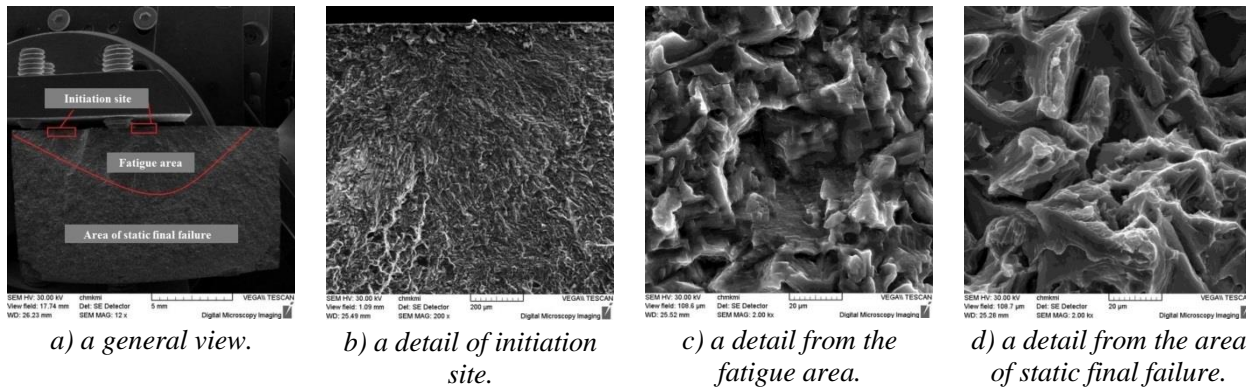
Fig. 6: Fracture surface of aluminium alloy 51500, $\sigma_a = 138$ MPa, $N_f = 799229$ cycles.

A general view of the fracture area for the alloy EN AC 51500 after 799229 cycles at a stress of 138 MPa is shown in Fig. 6a. Here can be seen that when higher amplitude of stress was applicate, the fatigue crack was spread from several initiation sites on the specimen surface and there was also a reduction of the fatigue area. Detail of one initiation site is shown in Fig. 6b. Transgranular fatigue failure of α -phase (matrix) and there were observed typical signs of fatigue – striations as it is shown in Fig 6c. Fig. 6d displays the area of static final failure, where can be also seen plastic's transformed ridges of α -phase, together with transgranular ductile fracture of α -phase with dimple morphology and also is visible an interfacial failure of Mg_2Si phase.

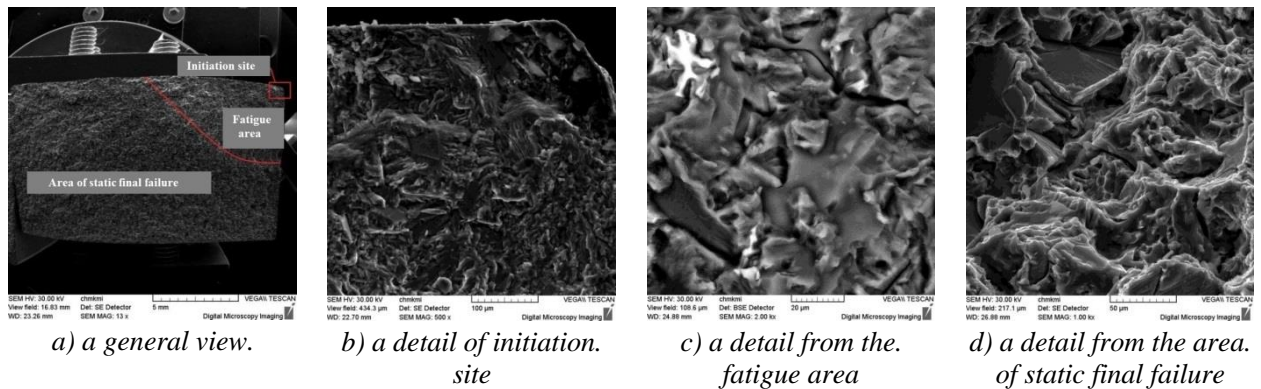
Fig. 7: Fracture surface of aluminium alloy 51200, $\sigma_a = 124$ MPa, $N_f = 761899$ cycles.

A general view of the fracture area for the alloy EN AC 51200 after 761899 cycles at a stress of 124 MPa is documented in Fig. 7a, where can be seen various stages of fatigue process. Detail of initiation site is shown in Fig. 7b. In Fig 7c can be seen an interfacial failure of intermetallic phases (Al_3Mg_2 , $Al_6(FeMn)$ and Mg_2Si) and also a transgranular fatigue failure of α -phase (matrix). Fig. 7d displays the area of static final failure, where can be seen interfacially broken intermetallic phases and plastic's transformed ridges of α -phase, together with transgranular ductile fracture of α -phase with dimple morphology.

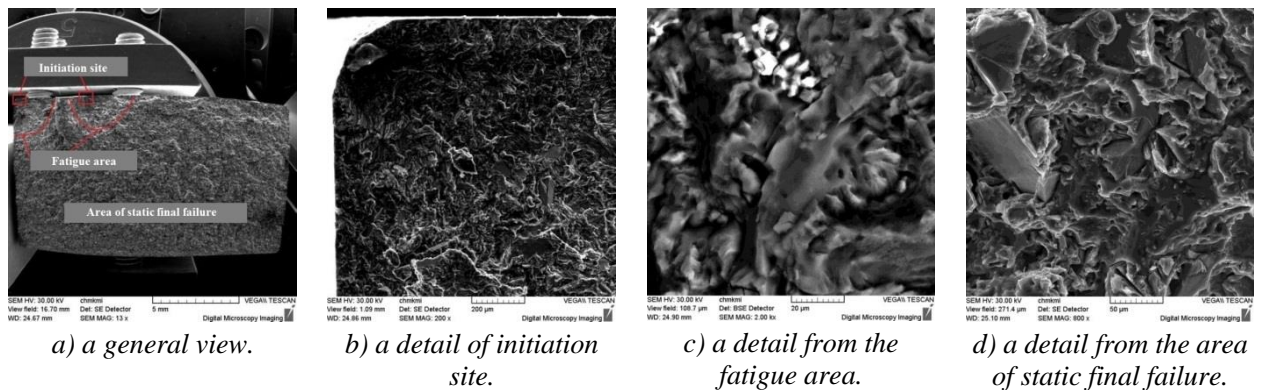
Fig. 8: Fracture surface of aluminium alloy 51200, $\sigma_a = 139$ MPa, $N_f = 150530$ cycles.

A general view of the fracture area for the alloy EN AC 51200 after 150530 cycles at a stress of 139 MPa is shown in Fig. 8a. Here can be seen that when higher amplitude of stress was applicate, the fatigue crack was spread from several initiation sites on the specimen surface and there was also a reduction of the fatigue area and a smaller number of cycles to fracture. Detail of one initiation site is shown in Fig. 8b. In Fig 8c can be seen a transgranular fatigue failure of α -phase (matrix) and also an interfacial failure of intermetallic phases (Al_3Mg_2 and $Al_6(FeMn)$). Fig. 8d displays the area of static final failure, where can be seen plastic's transformed ridges of α -phase, together with a transgranular ductile fracture of α -phase with dimple morphology and also is visible an interfacial failure of Mg_2Si and Al_3Mg_2 phases.
